Martin Community College

MASTER PLAN 2017-2022

Williamston, North Carolina

JKF Project No. 2017-12
November 21, 2017

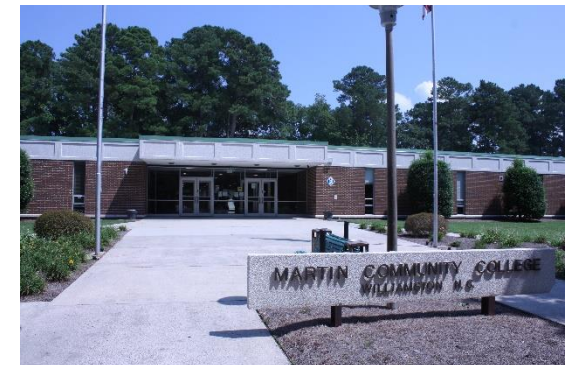
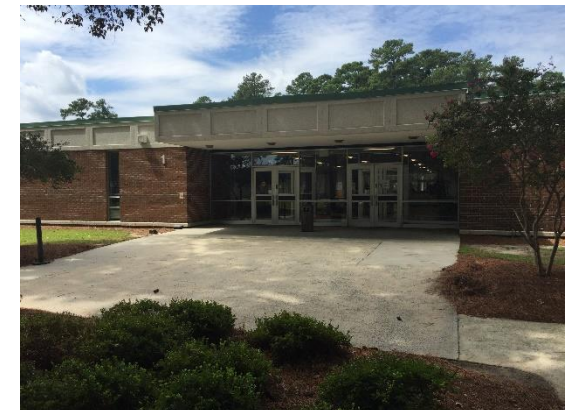
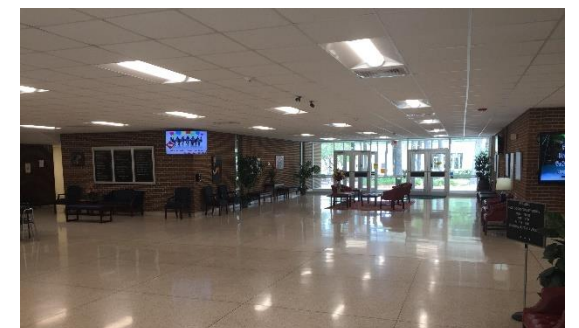
Building #1 - Administration Building

- **Exterior Walls:** Exterior walls are constructed of CMU, a minimal air gap, and face brick with stone banding. R-value of insulation is unknown. Brick, CMU, and stone are in good condition.

- **Roof:** The building originally had a black membrane roof, which was replaced three-five years ago by a white membrane roof.
- **Windows:** Original windows are aluminum, non-insulated and operable.

- **Storefronts and Entrances:** Aluminum non-thermally broken storefront air locks at Lobby entrances. Aluminum non-thermally broken storefront also located at end of Corridor.

- **Electrical - Lighting and Power:** Exterior soffit lights are antiquated. LED 2x4 lights have replaced original fixtures in some rooms. Old 1x4 and 2x4 fixtures remain in other rooms. Abandoned equipment above new ceilings.

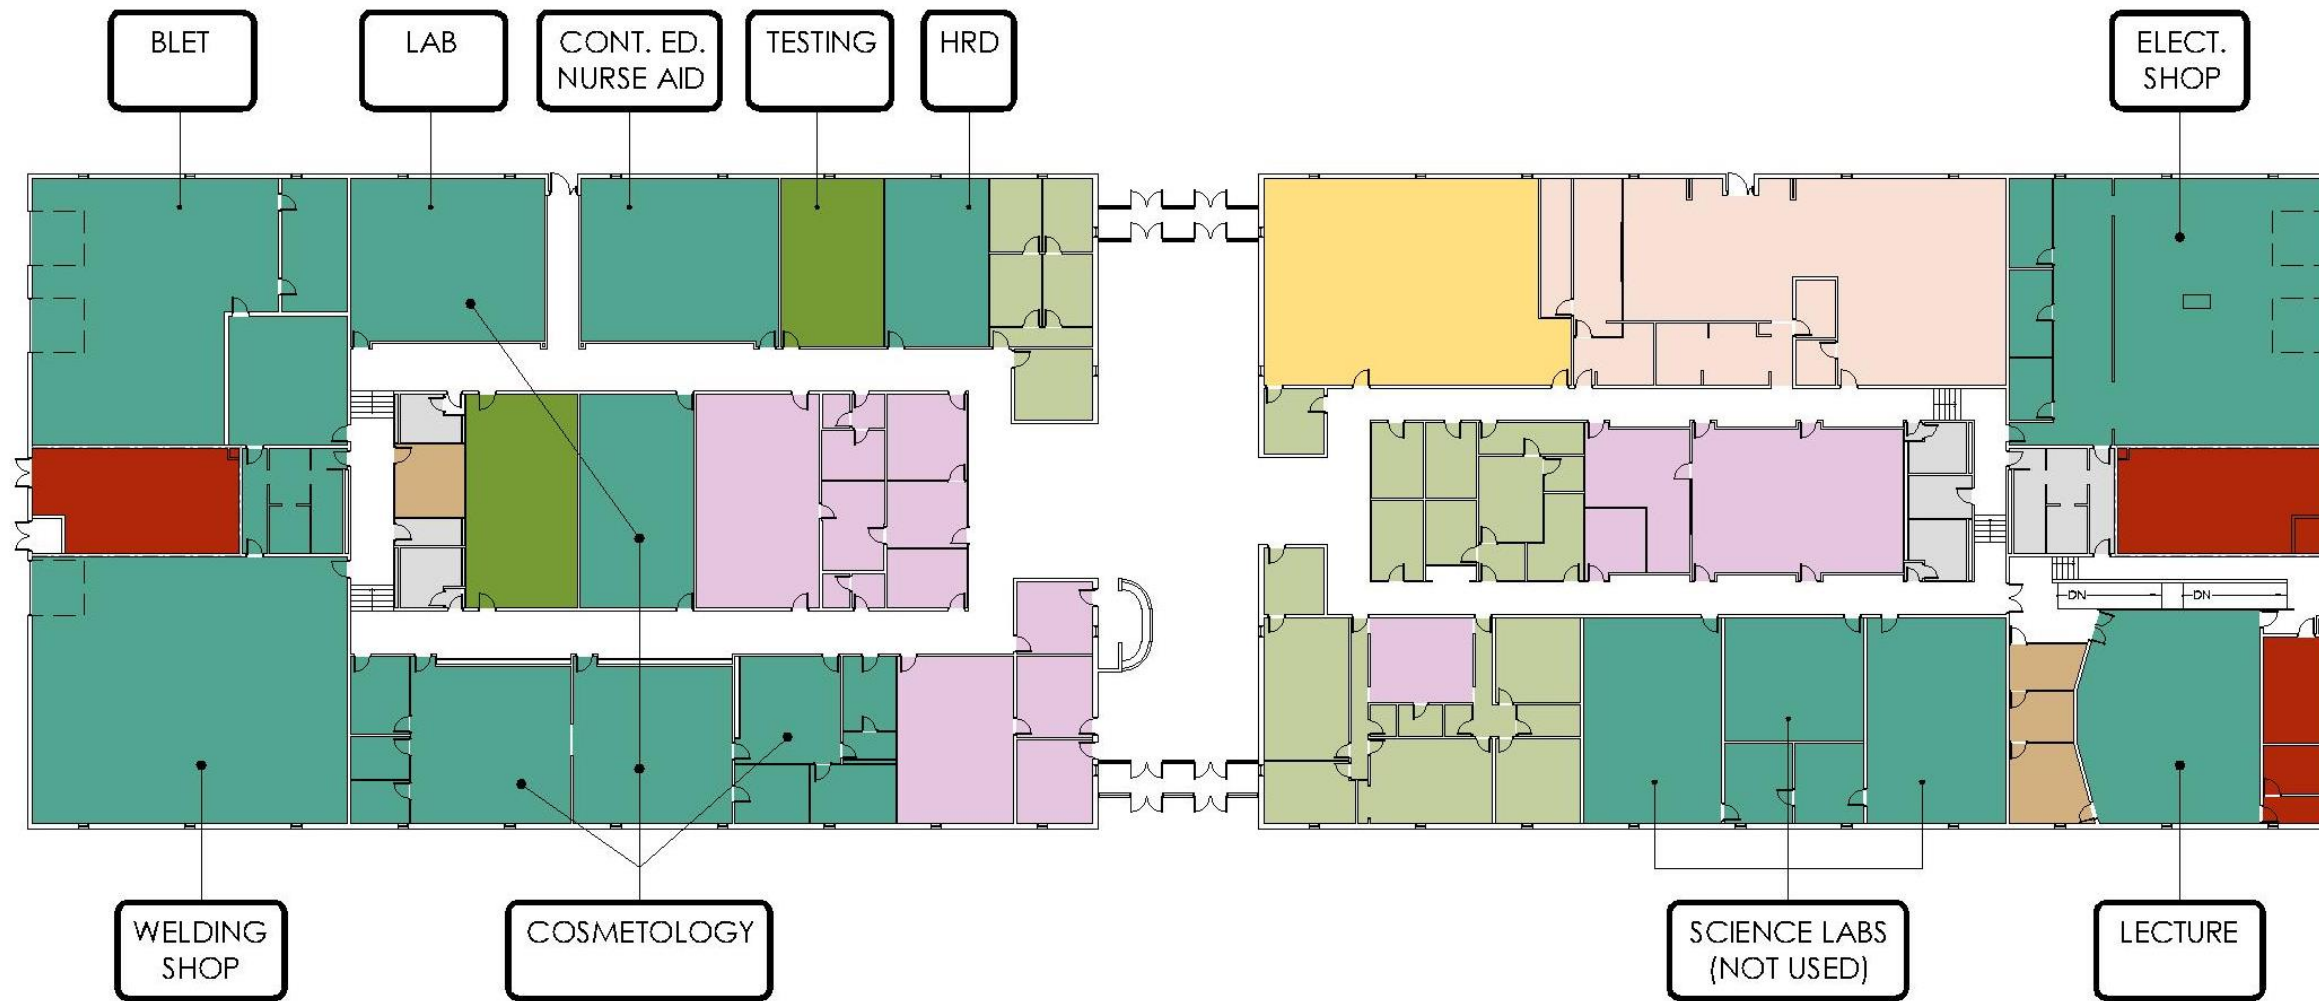
This 53,146 SF building was constructed in 1971 and has an assignable area of 36,852 SF. It houses a variety of activities, including administration offices, classrooms, cosmetology, science labs, as well as the electrical repair shop and Basic Law Enforcement Training (BLET).

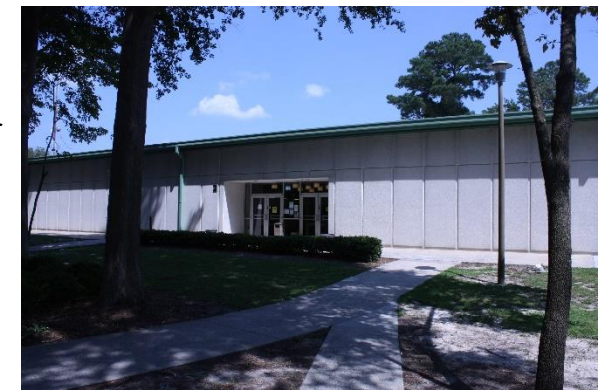
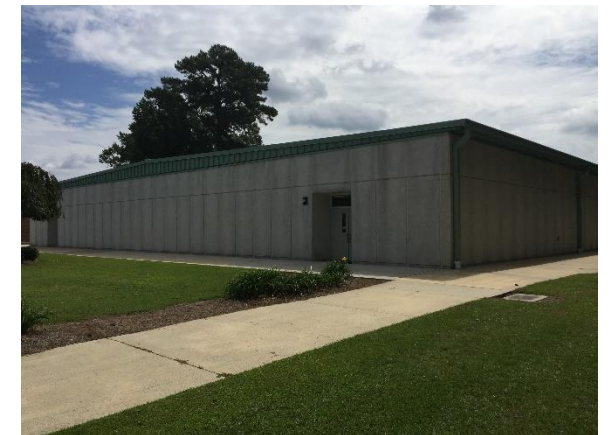
Building #2

- Exterior Walls: Exterior walls are constructed of CMU, a minimal air gap, and stone panels. R-value of insulation is unknown. CMU and stone are in good condition. Building is steel-framed construction.

- Roof: Building has a retrofit metal roof.
- Windows: None.
- Storefronts and Entrances: Aluminum non-thermally broken storefront air locks are at Lobby entrances. Aluminum/FRP doors are located at ends of Corridor.

- Plumbing: Plumbing fixtures are antiquated. Water coolers may not be accessible to Persons with Disabilities.
- HVAC: Diffusers are antiquated.
- Electrical – Lighting and Power: Lights are antiquated 2x4 and 6"x4 surface mounted fixtures.

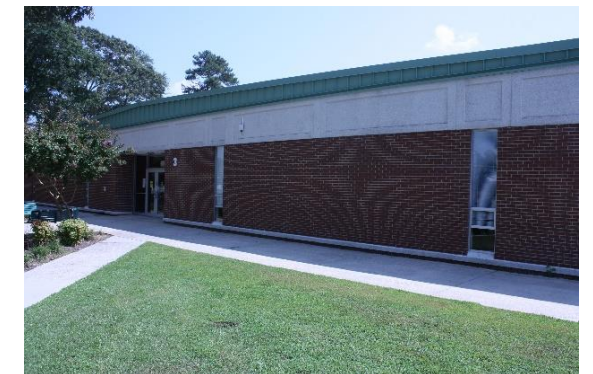
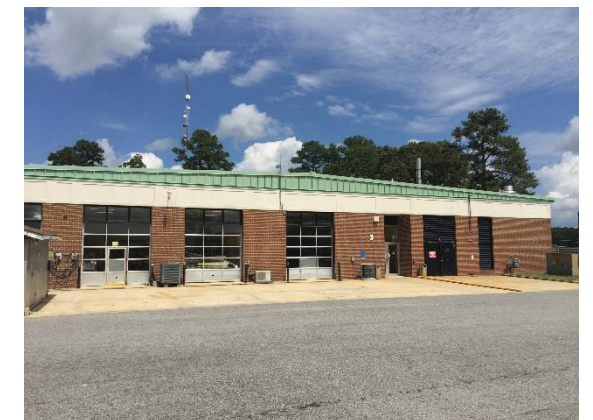
Building #3

- Exterior Walls: Exterior walls are constructed of CMU, a minimal air gap, and face brick with stone banding. R-value of insulation is unknown. Brick, CMU, and stone are in good condition. Building is steel-framed construction.

- Roof: Building has a retrofit metal roof.
- Windows: Original windows are aluminum, non-insulated and operable.
- Storefronts and Entrances: Aluminum non-thermally broken storefront is at Lobby entrance. Aluminum non-thermally broken storefront also located at end of Corridor. Exterior garage doors are located in the Shops.

- Plumbing: Plumbing fixtures are antiquated. Water coolers may not be accessible to Persons with Disabilities.
- HVAC: Diffusers are antiquated.
- Electrical – Lighting and Power: New retrofitted LED 2x4 fixtures are located throughout Corridors. Antiquated surface mounted 2x4 fixtures are located elsewhere throughout the building.

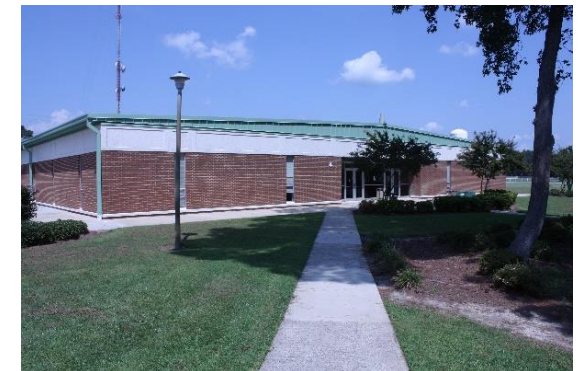
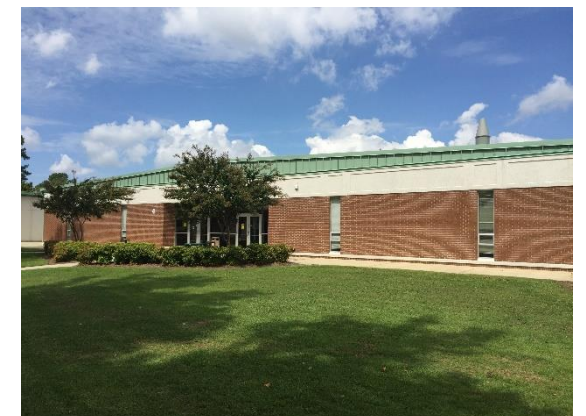
Building #4

- **Exterior Walls:** Exterior walls are constructed of CMU, a minimal air gap, and face brick with stone banding. R-value of insulation is unknown. Brick, CMU, and stone are in good condition. Building is steel-framed construction.

- **Roof:** Building has a retrofit metal roof.
- **Windows:** Original windows are aluminum, non-insulated and operable.
- **Storefronts and Entrances:** Aluminum non-thermally broken storefront is at Lobby entrance. Aluminum non-thermally broken storefront also located at end of Corridor.

- **Plumbing:** Plumbing fixtures are antiquated. Water coolers may not be accessible to Persons with Disabilities.
- **HVAC:** Diffusers are antiquated. Building may have significant water infiltration problem; rust is on diffusers throughout.

- **Electrical – Lighting and Power:** New retrofitted LED 2x4 fixtures are located in some rooms. Antiquated surface mounted 2x4 fixtures are located elsewhere throughout the building.

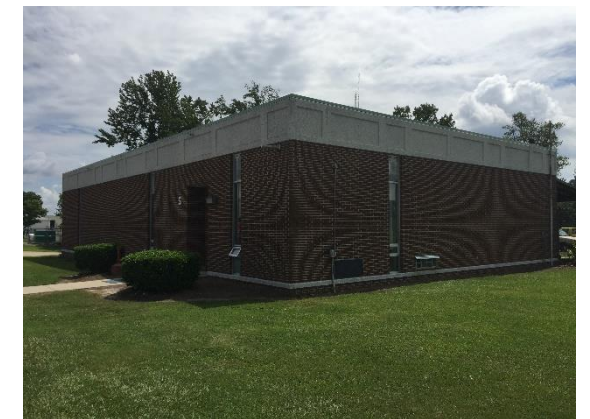
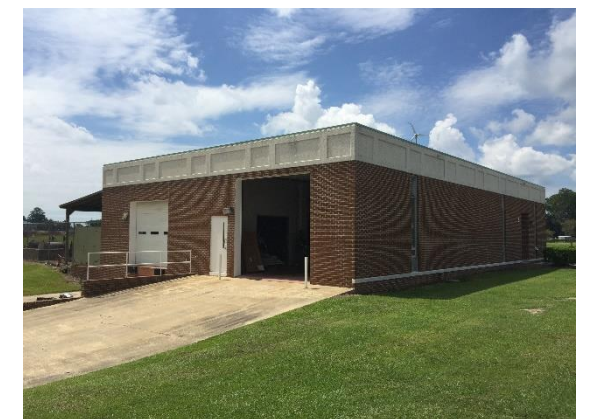
Building #5

- Exterior Walls: Exterior walls are constructed of CMU, a minimal air gap, and face brick with stone banding. R-value of insulation is unknown. Brick, CMU, and stone are in good condition. Building is steel-framed construction. A wood framed covered area is located to the South side of the building.

- Electrical - Lighting and Power: Retrofit 2x4 LED are in the Office area, and original linear fixtures are located throughout the Shops.

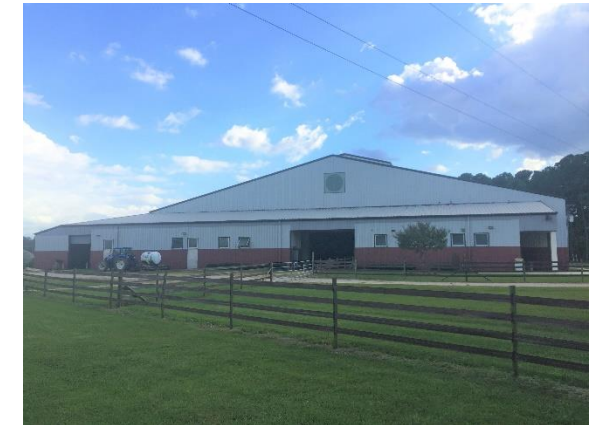
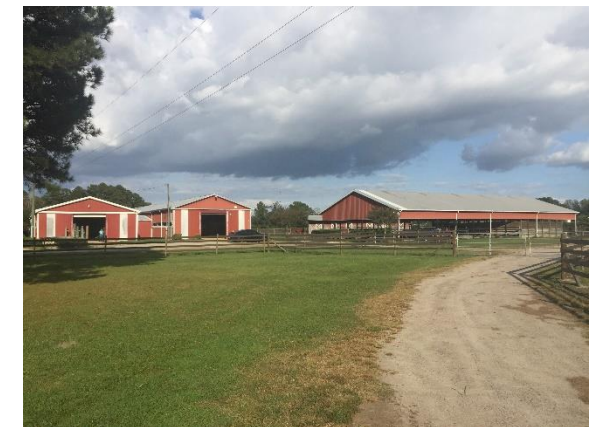
Building #6 – Equine Facility

- Interior walls: Interior walls are constructed of CMU.
- Ceilings: APC ceiling is located in the Lobbies and adjacent restrooms and concessions rooms and appears to be in good condition. Open ceiling throughout Arena, Stall areas, and Storage areas have roof blanket insulation that is in poor condition and needs replacement or repair.

- Floors: Ceramic tile is located in Lobby areas. Exposed concrete is in the Storage areas and Bleachers. Compacted earth is in the Stall areas, and Loose earth is in the Arena.

- Fire Protection:
- Plumbing: Plumbing fixtures are antiquated. Water cooler may not be accessible to Persons with Disabilities.
- HVAC: Natural ventilation is used throughout the Arena and Stall areas and need upgrade. Lobby and Restroom areas are conditioned.

- This Building was constructed under the 1978 Building Code and utilized Fire-protection of the supporting columns and Fire-wall construction to build a facility this large. No additions, change of use, or expansions of any kind can be done to the building without requiring the entire facility to meet current Codes including adding a Fire Protection (Sprinkler) System. A fire pump may also be required.

Given the size of the building and the available budget, JKF ARCHITECTURE recommends a comprehensive initial renovation of the building to make it user friendly, expand its capabilities, and correct deficiencies that have accumulated over the years. This recommendation represents a first phase of much needed repairs and renovation to upgrade the facility. An initial repair and renovation project will not trigger a Code compliance that would typically include installation of a new Fire Protection System (Sprinkler) and possibly a Fire Pump.

- The building must be brought up to comply with the Americans With Disabilities Act (ADA). Currently, the only ADA compliant restroom cannot be accessed from the bleachers. This means the north side restrooms must be altered to be accessible.
- New exterior walkways should be installed for Code-required egress to the public way.
- Replace damaged exterior walls and roof panels.
- Replace all windows to increase energy efficiency and daylight usage in the building.
- Replace or repair all gutters and downspouts.
- Replace antiquated exterior rollup doors.
- Renovate the stable areas to include more efficient use of space overall, increased stable capacity, and improved work space. Eliminate the interior storage of haybales.
- Existing space under the arena bleachers should be reclaimed and renovated to serve as a modern location for revenue generating vendor and/or concession areas.

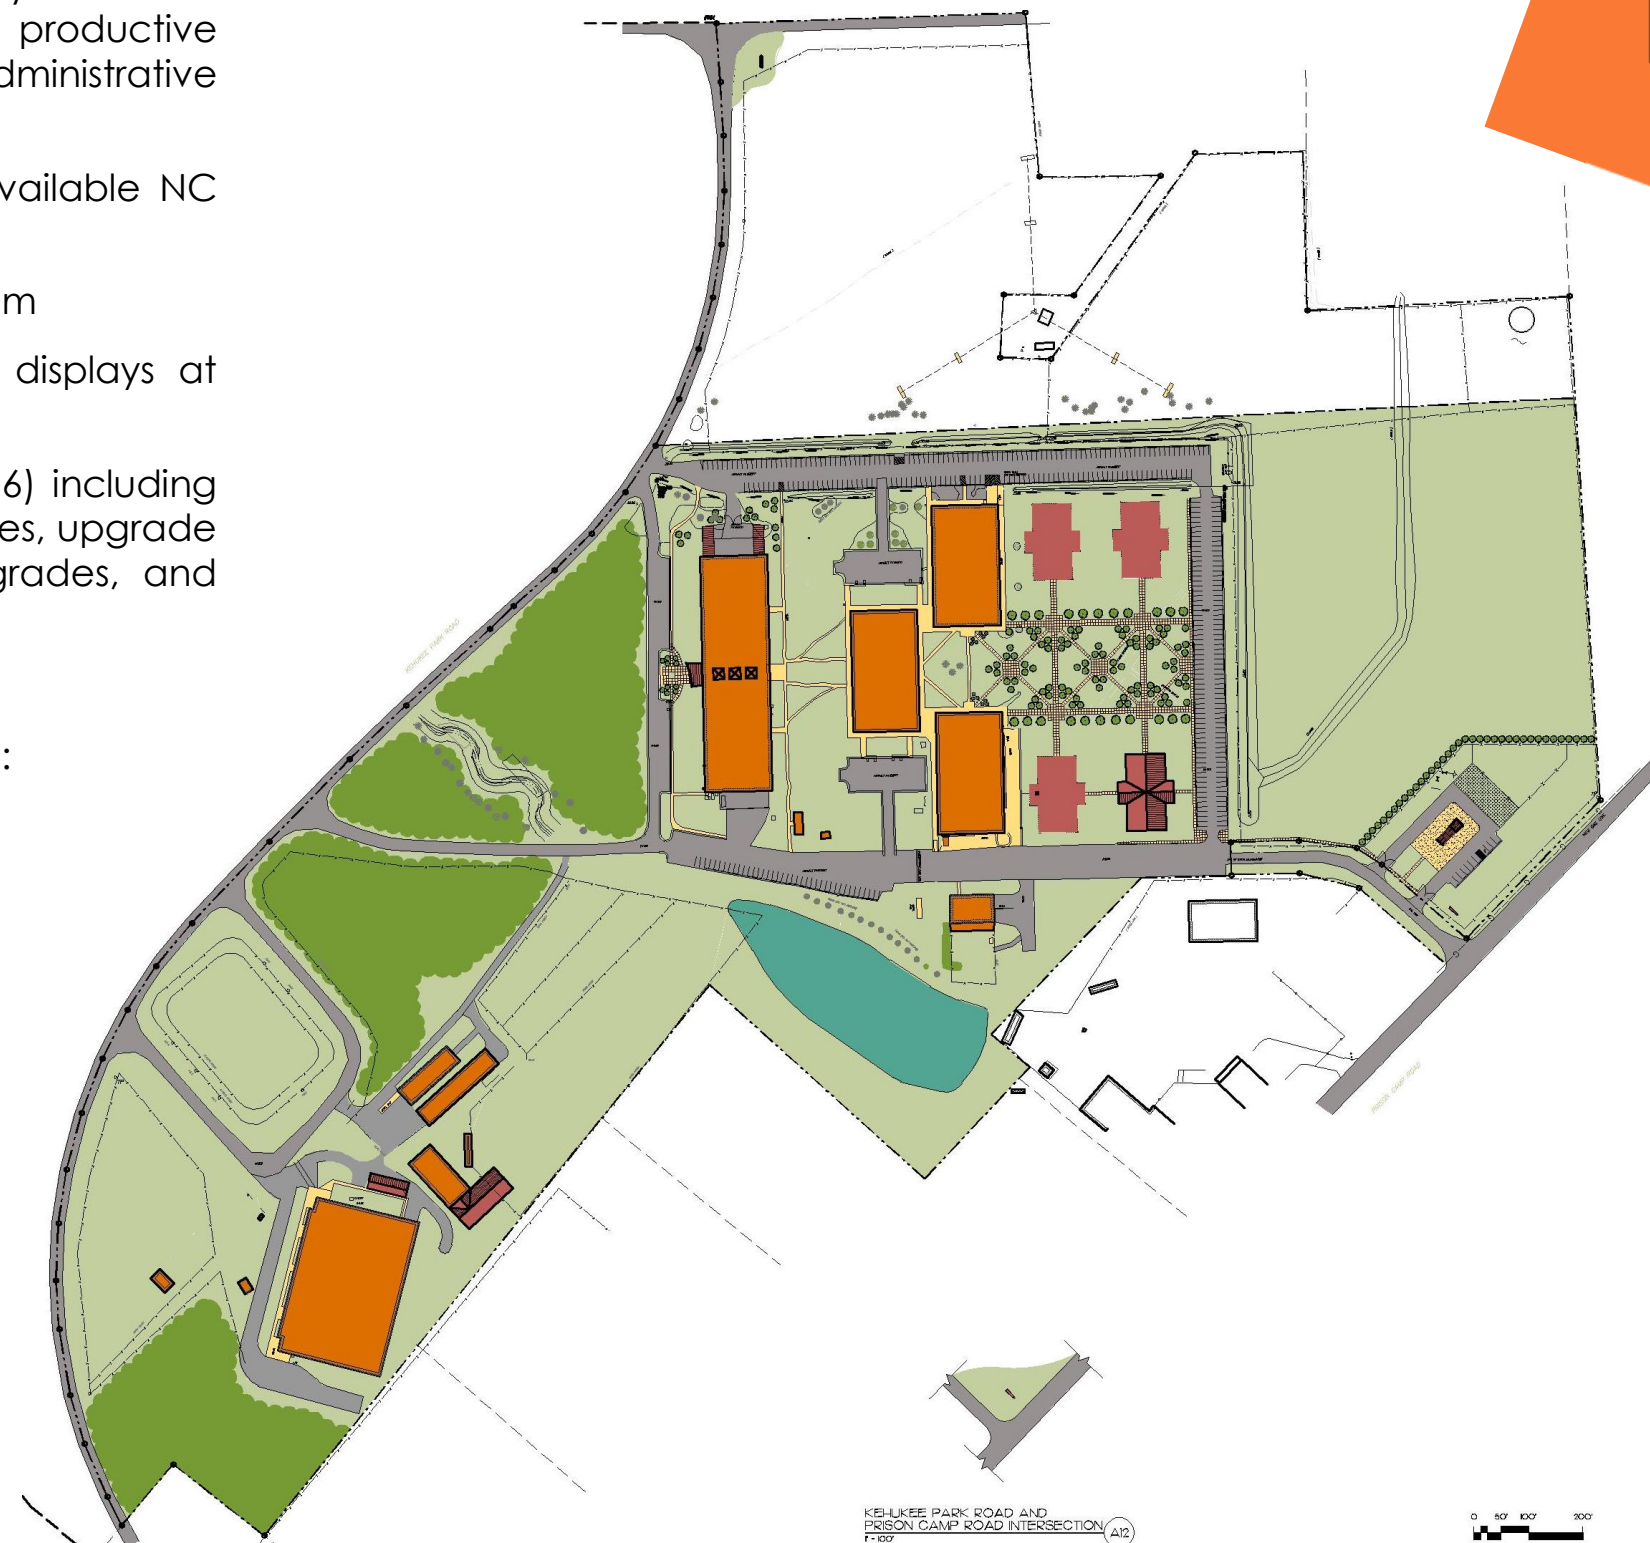
VIII. PROPOSED MASTER PLAN

- A new Burn Tower for the Public Safety program
- New campus entry signage including LED displays at critical entrance locations.
- Renovation to the Equine Facility (Building #6) including upgrades to the exterior envelope, new stables, upgrade to HVAC and electrical systems, ADA upgrades, and miscellaneous interior upgrades.
- A new Public Safety Classroom Building

- Equine Classroom Building
- Equine Colt Arena Expansion
- Building #1 Renovation
- Building #2 Renovation
- Building #3 Renovation
- Building #4 Renovation
- Building #5 Addition
